August 27, 1999

Project No. 4457-99

SUBJECT: FAULT AND SEISMIC INVESTIGATION FOR PROPOSED  
RESIDENTIAL DEVELOPMENT  
Tract 37-16  
Mono County, California

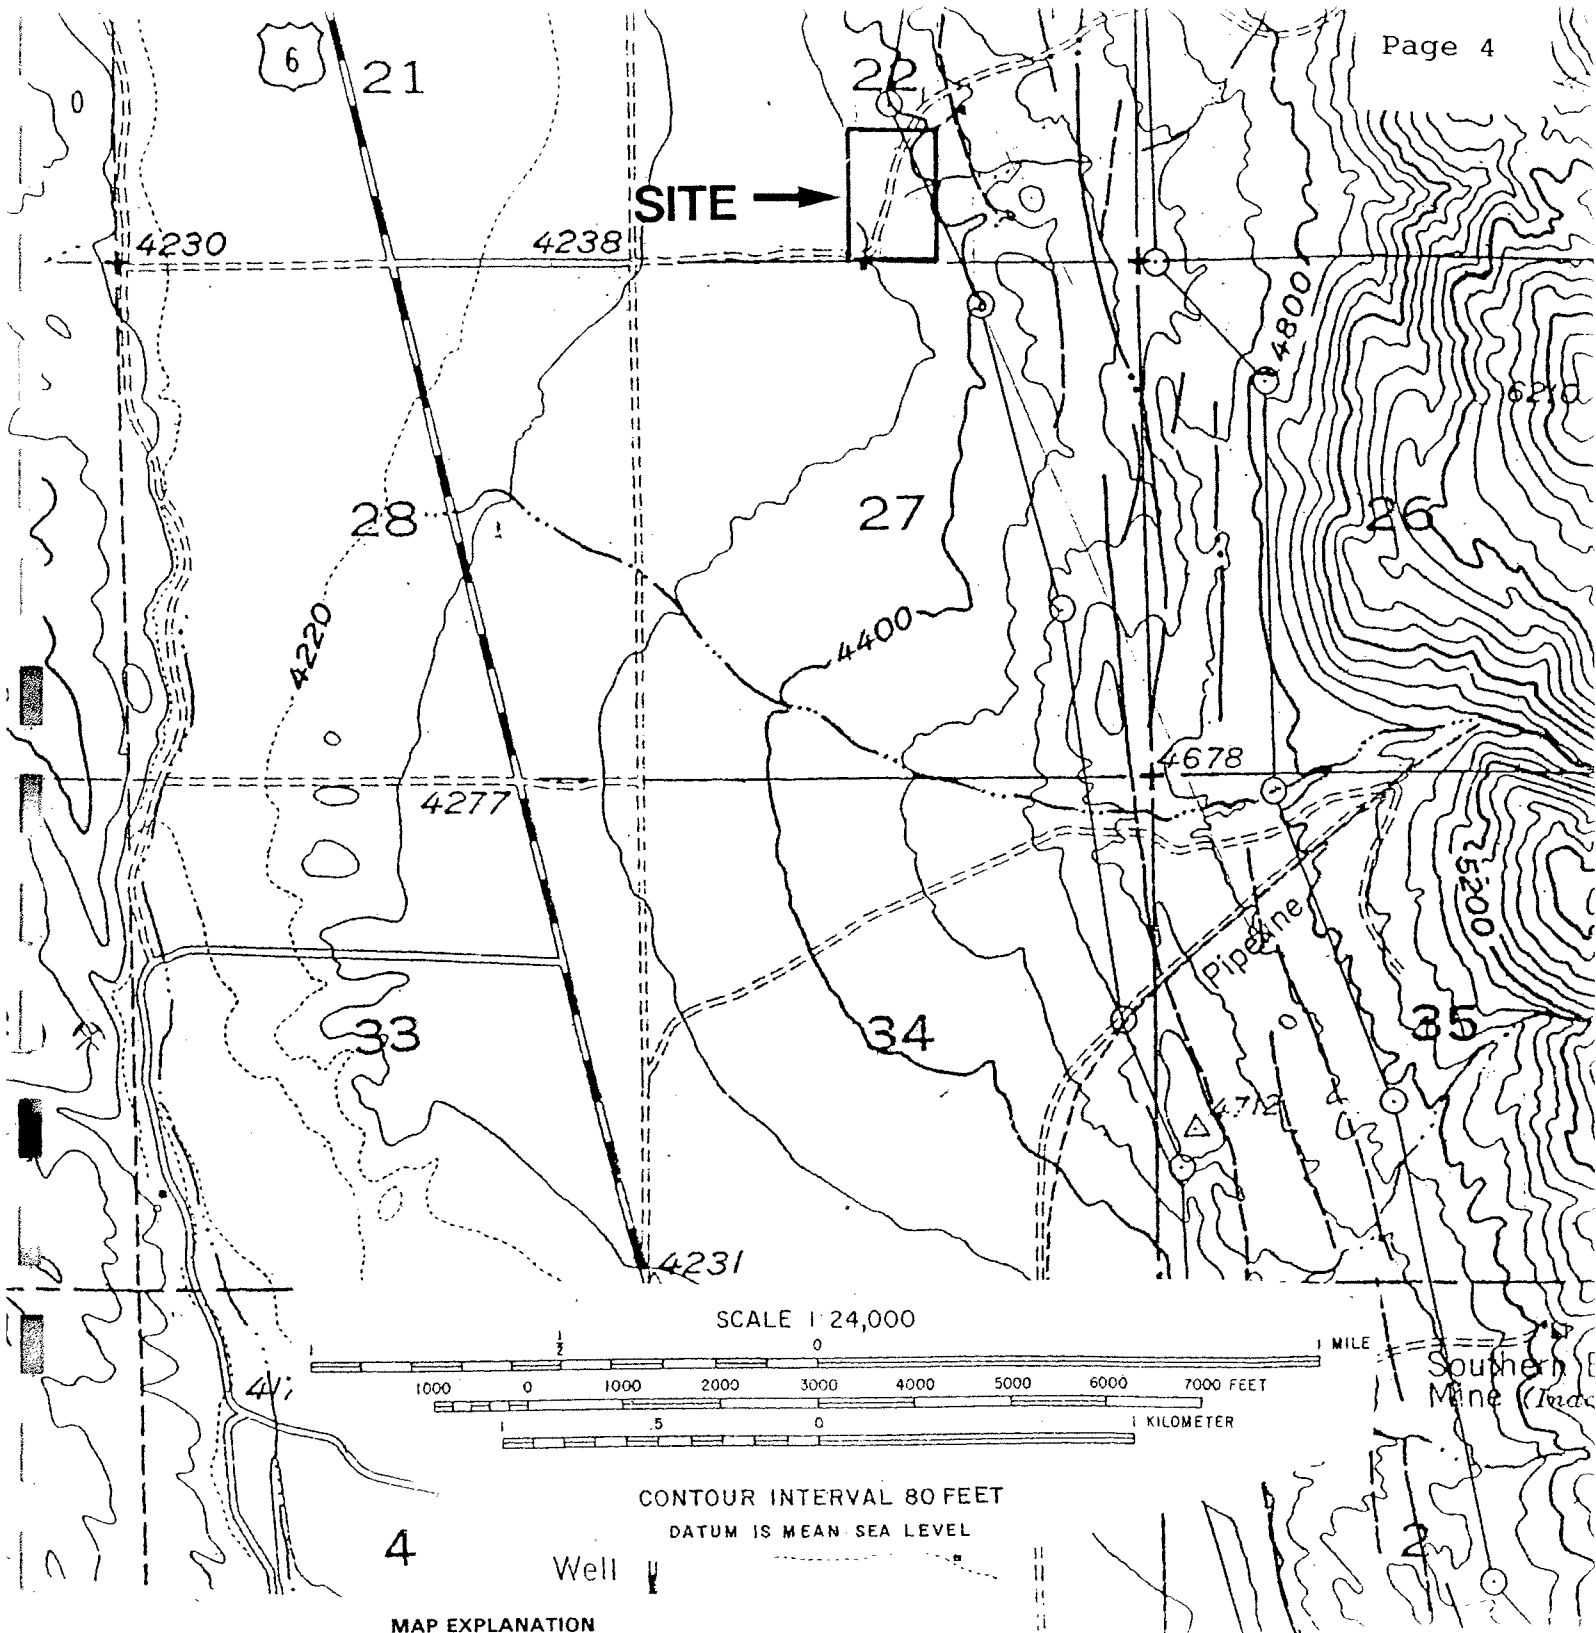
FIGURE 1

The site is located on the NE 1/4 of the Bishop 15 minute series Quadrangle. The northeasterly portion of the site is located in an Alquist-Priolo Special Studies Zone. Such Special Studies Zones have been designated along known active faults in California under the Alquist Priolo Special Studies Act which was signed into law March 7, 1973. The purpose of this act is to prohibit the location of structures for human occupancy across traces of active faults. Figure 1 shows the location of the site relative to the boundaries of the Special Studies Zone.

The Special Studies Zone map (NE 1/4 of the Bishop Quadrangle) shows a dashed trace of the White Mountains fault system as trending in a northerly-southerly direction about 180 feet easterly of the northeast corner of the site (refer to Plate 1 in pocket at back of this report and to Figure 1).

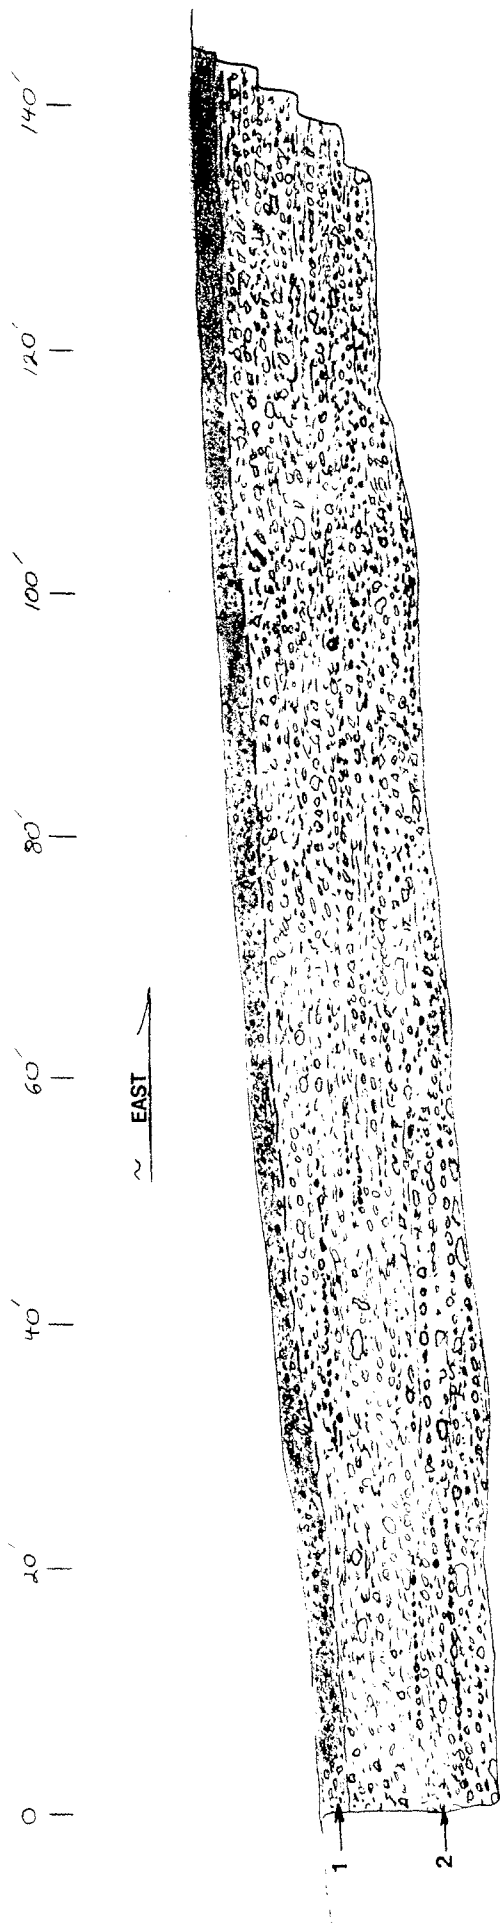
## SKETCH LOG OF FAULT TRENCH 1

Although most of the site is not located within the Alquist-Priolo Special Studies Zone, Fault Trenches 1, 2 and 3 were excavated across subtle breaks in slope. No faults were found.

1 SOIL: Light brown silty clayey sand, very loose, dry, scattered pebbles and cobbles, some boulders, scattered roots and rootlets.

2 ALLUVIUM: Silty clayey sand and gravel, brown, clasts range from subround to angular and from pebble to cobble size with some boulders. Poor to moderately well defined sub-horizontal layering. Layering defined by textural changes. Some imbrication of clasts. No faults, shears, or fissures observed.

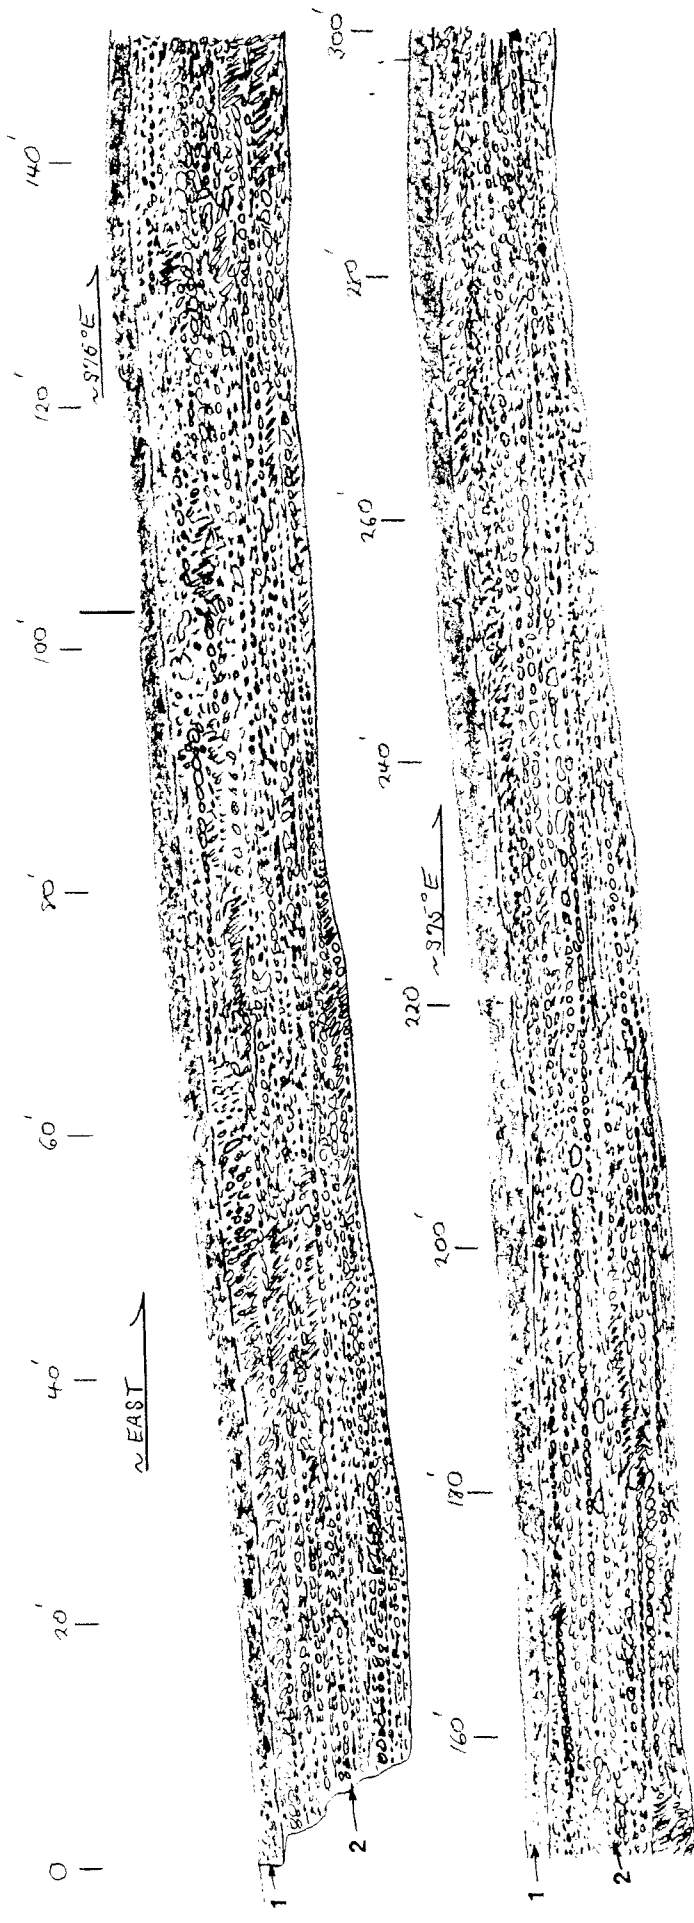
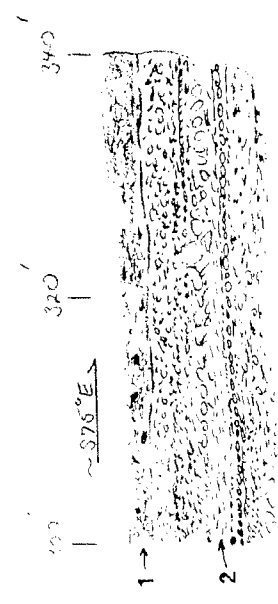
# SKETCH LOG OF FAULT TRENCH 4

Fault Trenches 4 and 5 were excavated within the portion of the property located in the Alquist-Priolo Special Studies Zone. Trench 5 was excavated across a "break-in-slope". No faults were found in the trenches. The break-in-slope is attributed to alluvial processes.
